### ASTM E2237 Drainage Efficiency Testing of Tanager Products DrainStrip™

Tanager Products, Inc.  
14048 Terrace Road NE  
Ham Lake, MN 55304

**Report Number:** 22-065

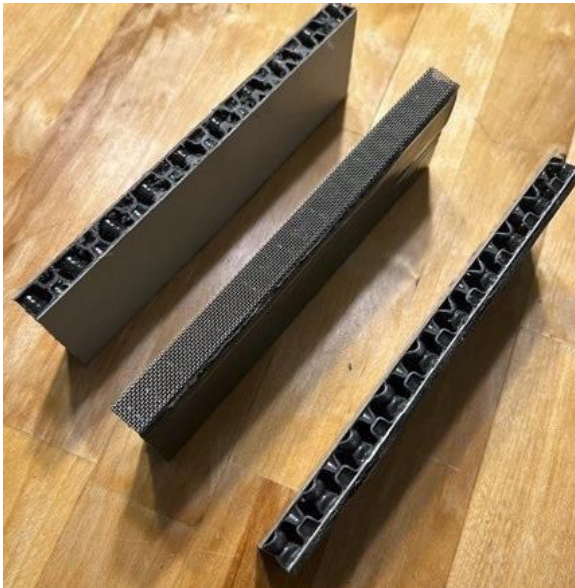
**Figure 1:** DrainStrip™ Close-Up

The Center for Building Innovation (CBI) tested two (2) rain screen systems featuring Tanager Product DrainStrips™ in general accordance with test standard *ASTM E2273-18: Standard Test Method for Determining the Drainage Efficiency of Exterior Insulation and Finish Systems (EIFS) Clad Wall Assemblies*. DrainStrips™ are 2" x ½" porous furring members that can be used as part of a rain screen system. DrainStrips™ consist of two plastic facers over an open-cellular plastic core. One of the facers is coated with a puttie that seals fasteners which have penetrated the weather resistant barrier. The DrainStrip™ located at the bottom of the system features a wire mesh covering the bottom edge that serves as an insect deterrent. Testing was conducted to evaluate the drainage efficiency of the DrainStrip™. Photographs of the DrainStrips™ and their layout are provided in **Figures 1 and 2**. A detailed description of specimen construction is provided in **Table 1**.

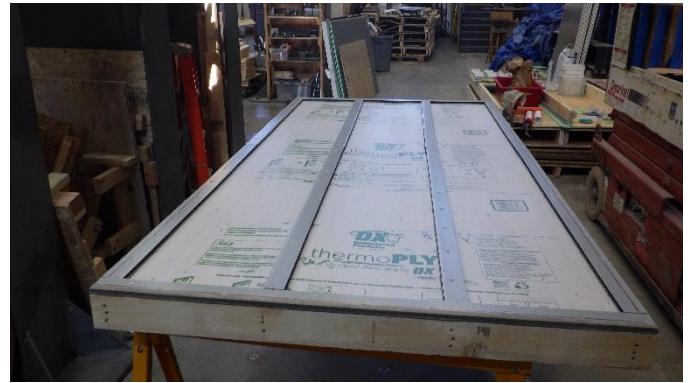
**Figure 2:** DrainStrip™ Layout

| Category | |
|---|---|
| Drainage Elements | (4) Vertical DrainStrips™ Spaced 16" o.c. (aligned with studs)<br>(2) Horizontal DrainStrips™ (aligned with top/bottom plates) |

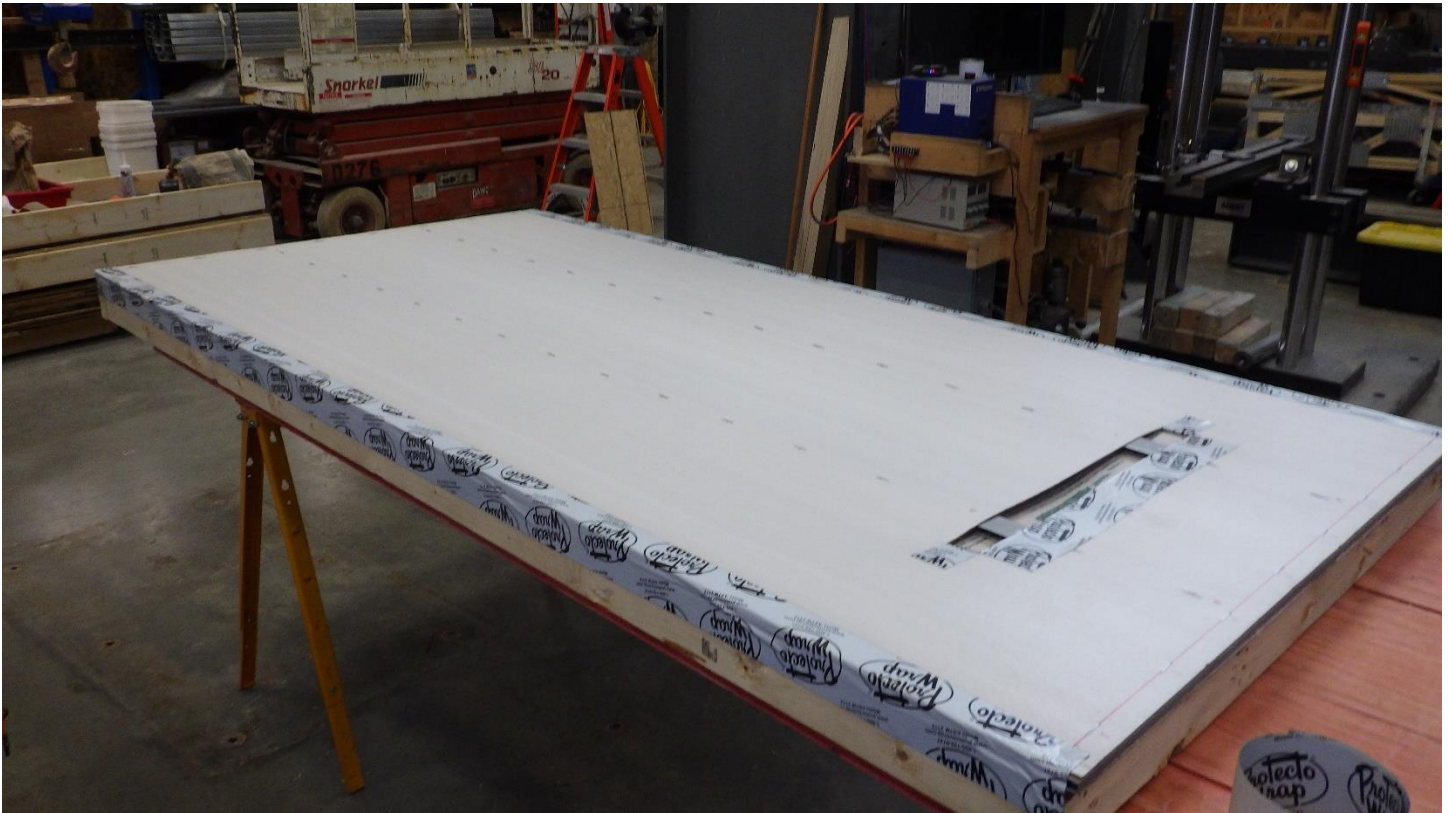
**Figure 3:** Test Specimen with Slot Fault

A wall was framed using industry standard methods and sheathed with Ox Thermo-Ply, a type of exterior sheathing that includes a weather resistant barrier. DrainStrips™ were then attached over the exterior sheathing. Finally, a second sheet of Ox Thermo-Ply was attached to the outside face of the DrainStrips™ to simulate any type of impermeable cladding material. Preliminary testing found that water clung to the bottom plate after passing through the rain screen system, so a thin strip of steel was inserted below the bottom DrainStrip™ to serve as a drip edge. The vertical edges of the wall panel were sealed. A slot fault (an opening in the test specimen that exposes the water or weather resistant barrier) was cut into the specimen. The slot fault was 24" wide by 2" high and positioned 12" from the top of the wall assembly. A photo of a finished test specimen with slot fault is shown in **Figure 3**.

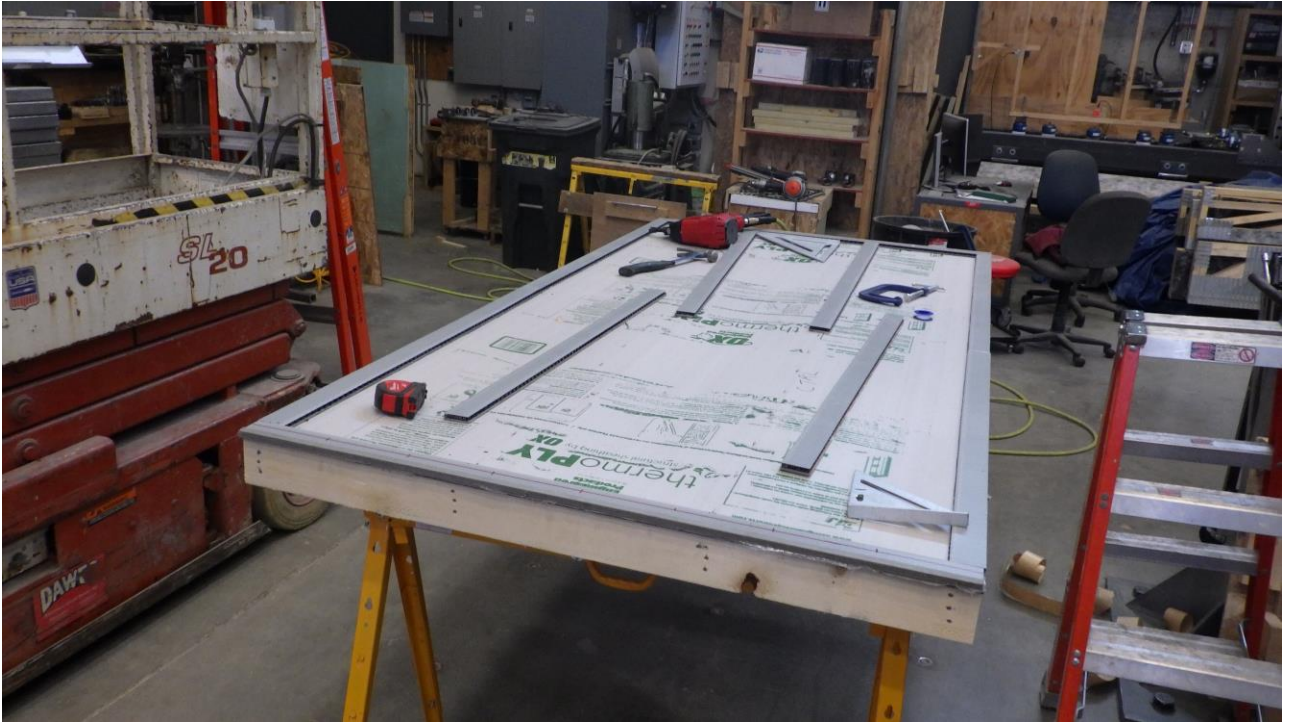
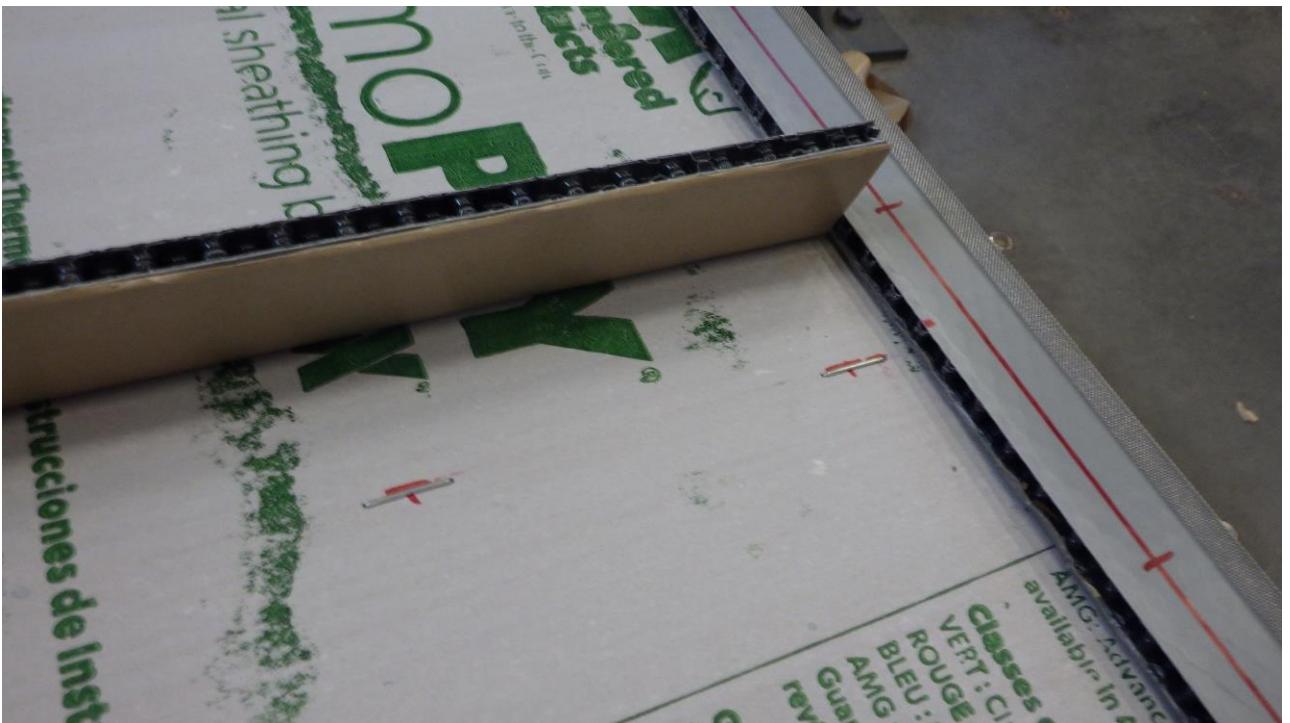
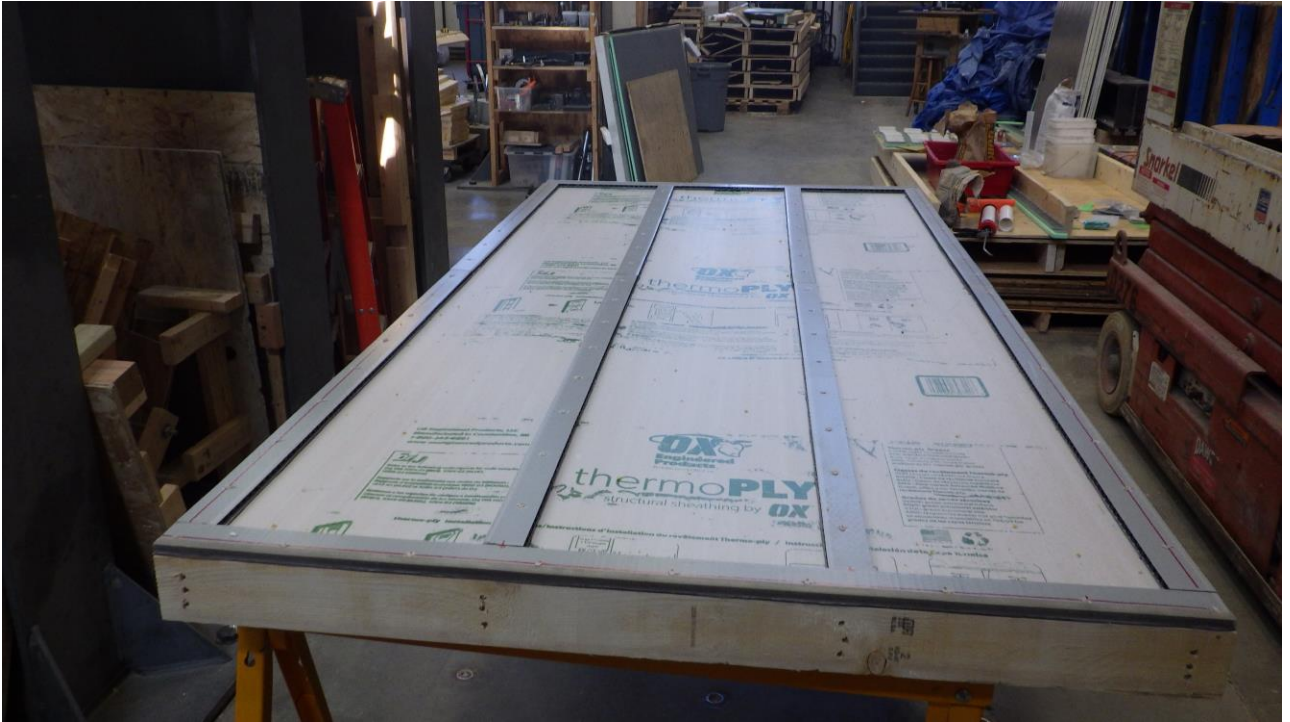
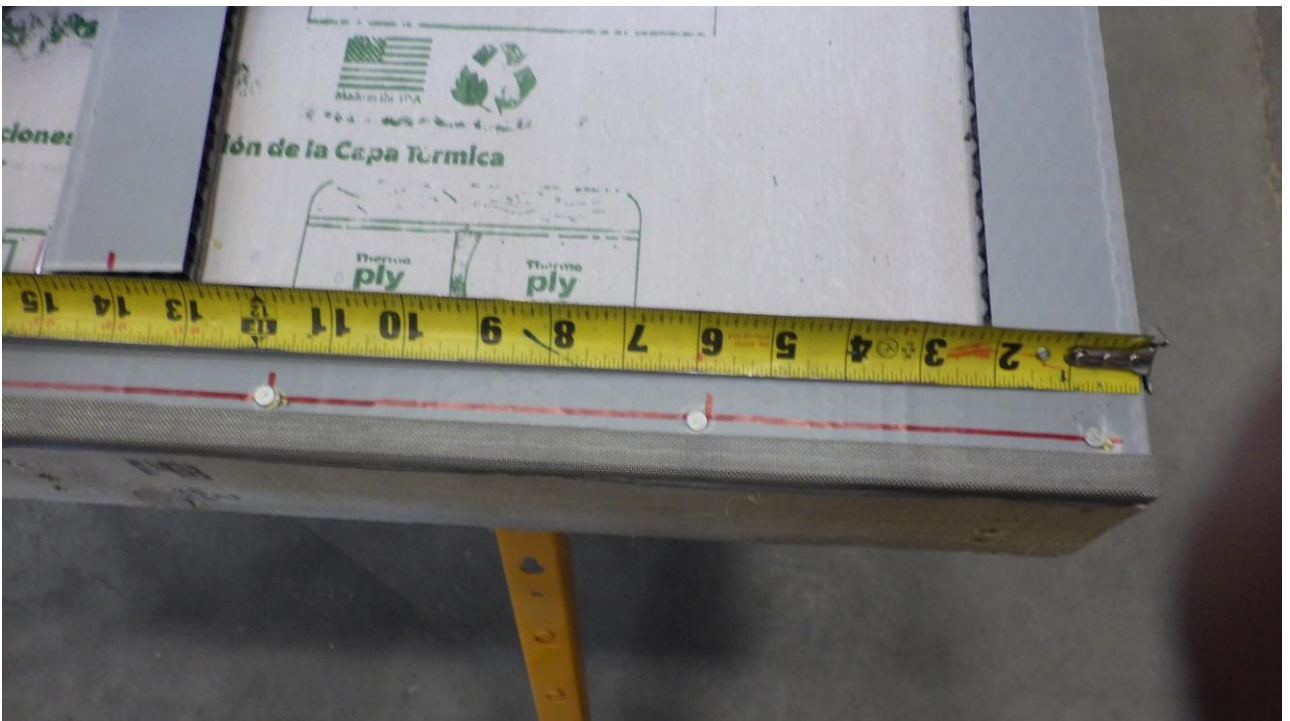
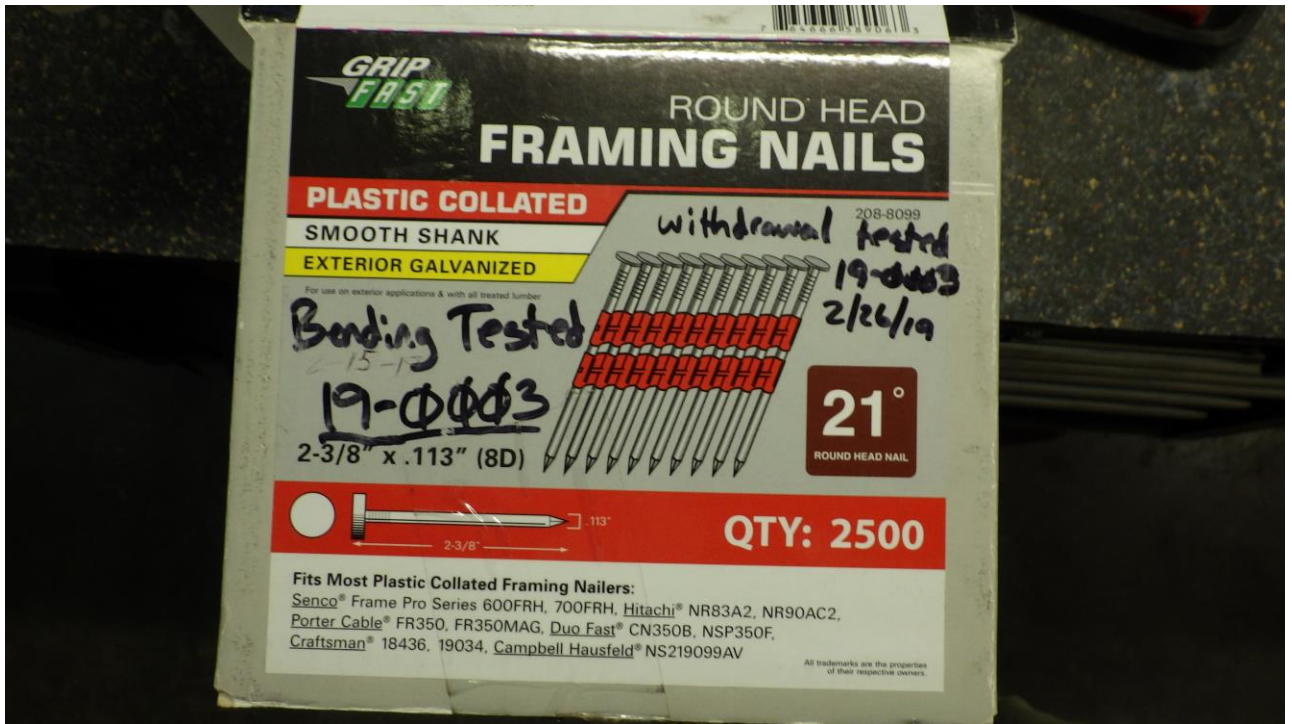
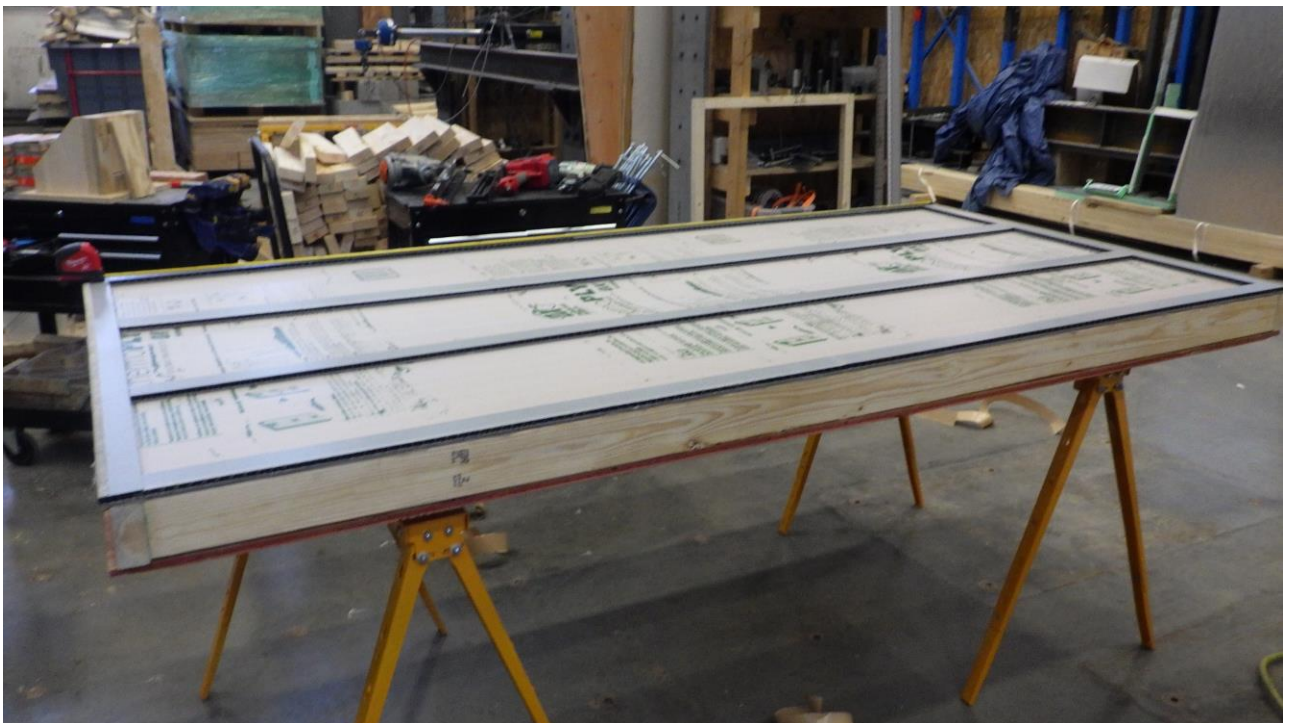
## **Appendix A:** **Photos**

The following pages contain photos from testing.
